CONNECTICUT SUPREME COURT BUILDING& LIBRARY (East Wing)

Building Location: 231 Capitol Avenue Hartford, Connecticut

Date of Site Visit: 01/03/07

Field Notes, Background & General Observations

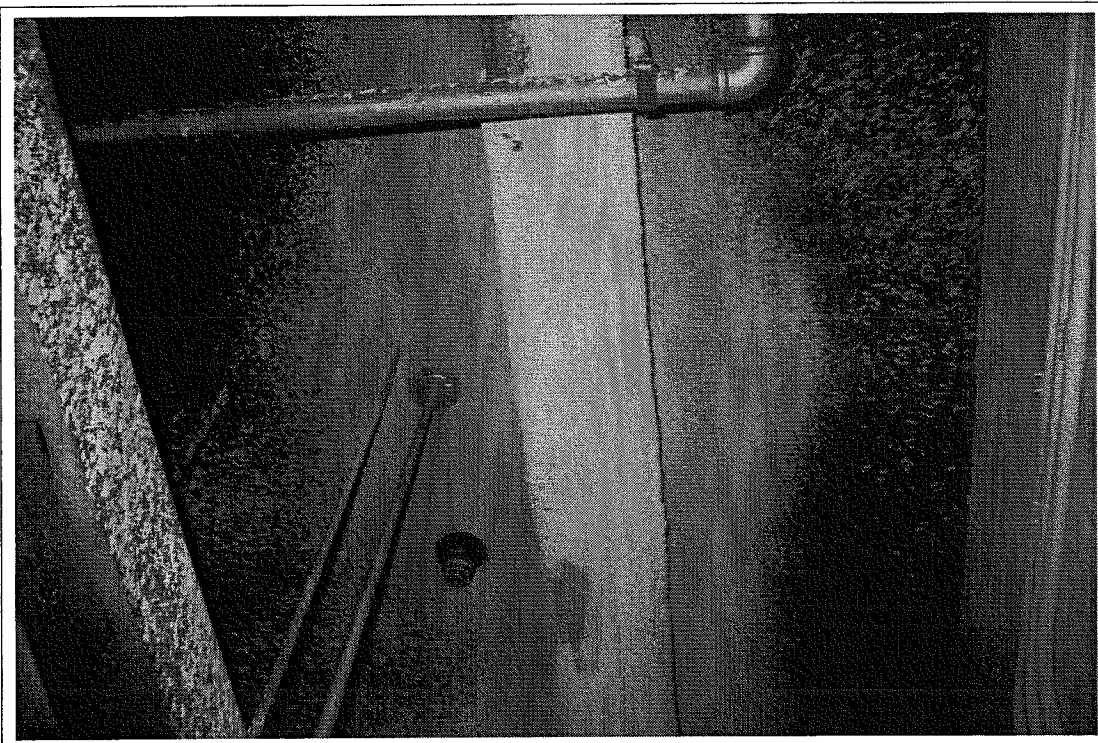
Photo 141. General view of fireproofing applied to I-beam with overspray on decking, HVAC duct work and hanger supports in the East wing, 2nd floor Telephone Closet

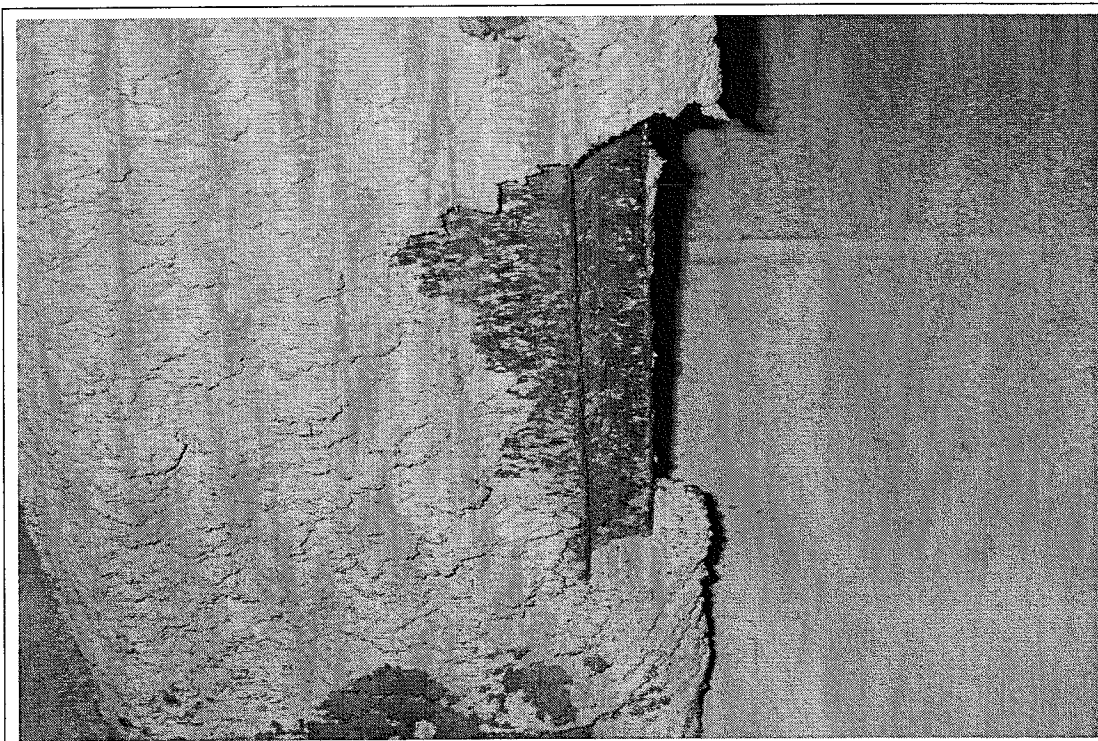
Material Damage: Obvious delamination observed throughout the application (evidenced by fireproofing dust, debris and small pea to fist size chunks deposited on horizontal surfaces below deck, including ceiling tiles, HVAC ducts and light fixtures).

Photo 142. Close-up of delaminated fireproofing missing from I-beam in the East wing, 2nd floor Telephone Closet

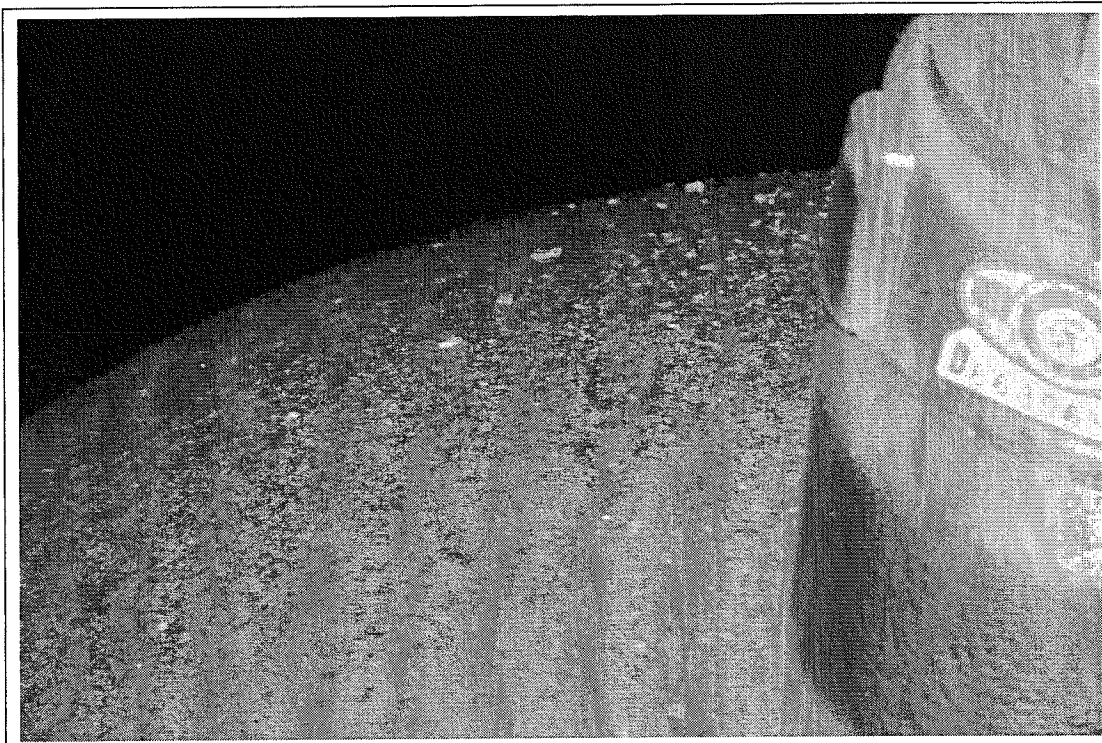
Photo 143. Close-up of delaminated fireproofing debris on top of incandescent light fixture in the East wing, 2nd floor Telephone Closet

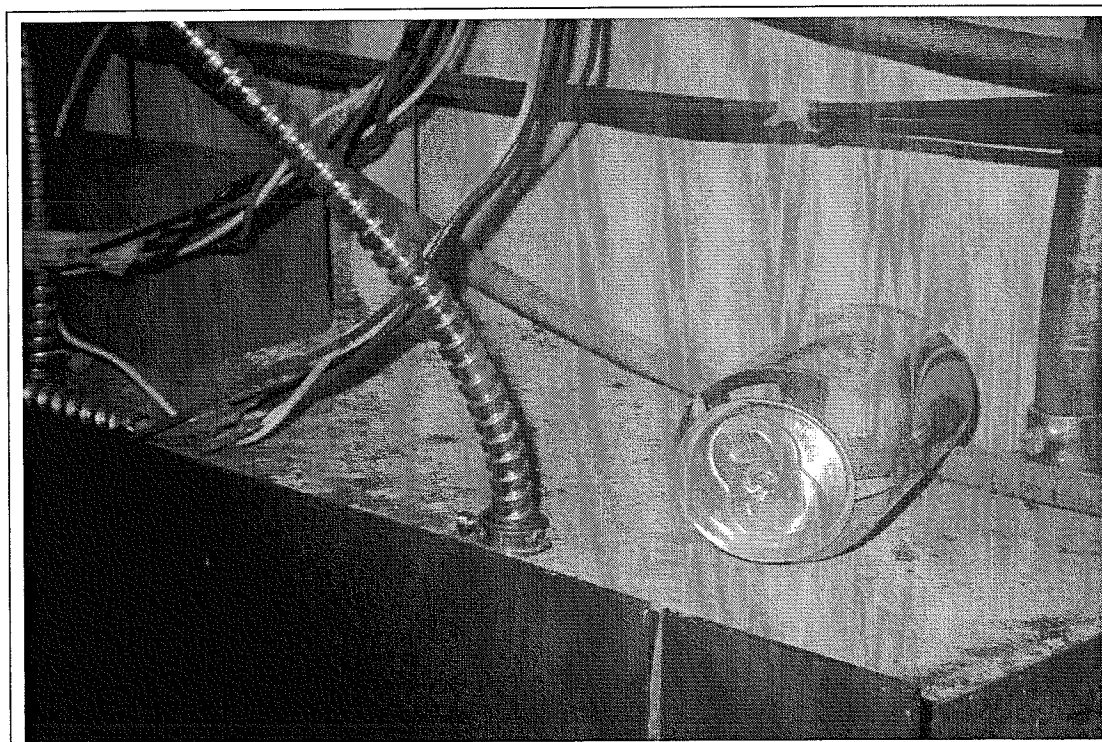
and color) made at the time of dust collection confirmed that the dust and debris collected in the samples were from delaminated/dislodged fireproofing applied directly above the vacuumed surface. Analysis of the dust samples indicates extreme contamination based on asbestos concentrations ranging from approximately 23.5 billion to 78.7 billion asbestos fibers per square foot. Refer to table below:

Photo 144. Location of Dust Sample #1 (top of electrical panel – beneath sprayed fireproofing) in the East wing, 2nd floor Telephone Closet

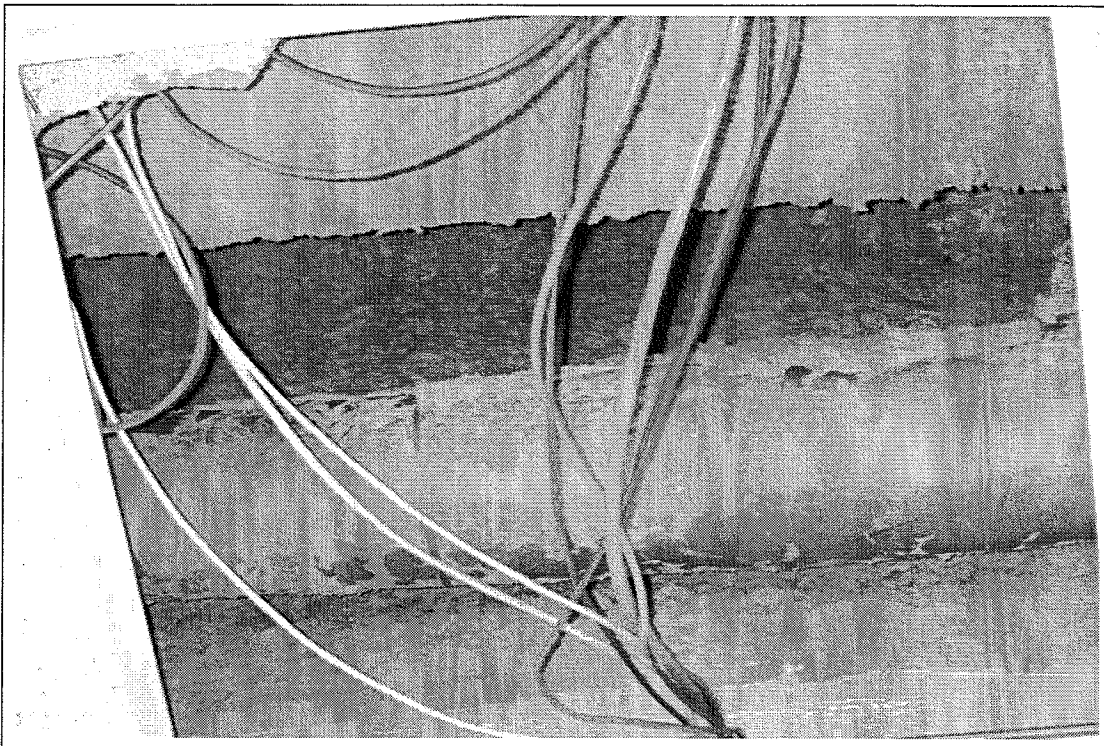
Photo 145. View of fireproofing applied to I-beam and perimeter wall with overspray on piping above missing lay-in style ceiling tiles, East wing, 2nd floor South entrance vestibule

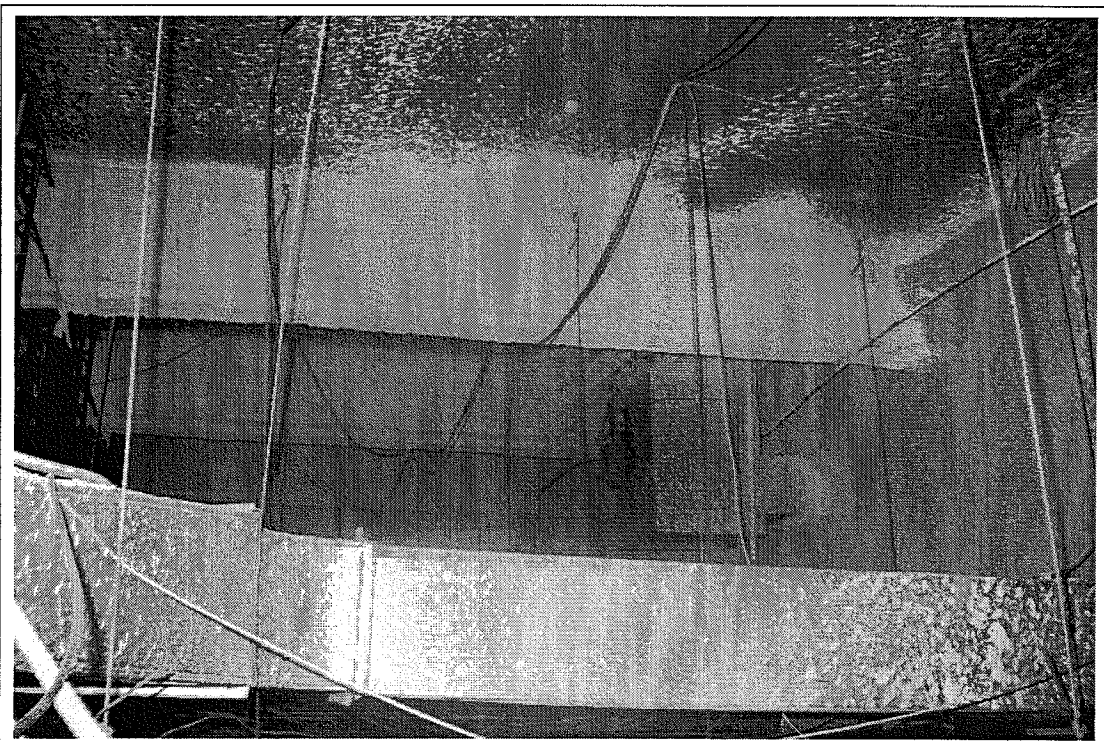
Photo 146. General view of fireproofing applied to I-beams and perimeter wall with overspray on ductwork above concealed spline ceiling system, East wing, 2nd floor Room L 211
